# VALID TREE RISK-BENEFIT SUMMARY REPORT

**For the trees within Knowle Wood  
At Leighwood Fields, Cranleigh, Surrey**

| <b>Document reference:</b> | MDJAC-23.068-VTRBSR-02 |
| <b>Date:</b> | 14 May 2024 |

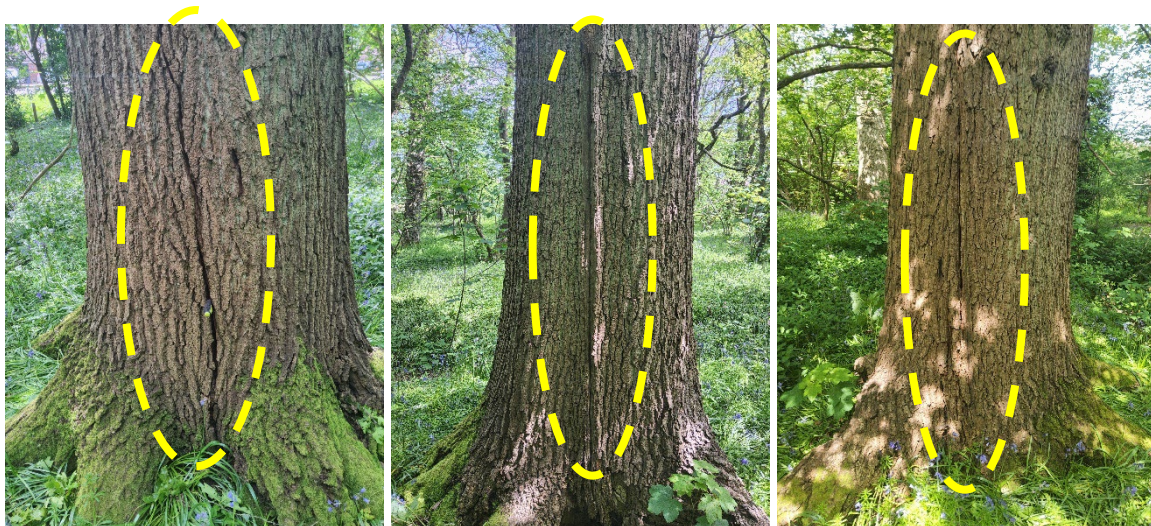
| Tree number | Species | Comments | Assessment level |
|---|---|---|---|
| T20 | English oak | Root loss on W aspect. Incipient decay. Large longitudinal cracks consistent with partial stem failure on N and S aspects. Possibly from 1987 Storm. Sparse canopy. | Detailed |

4.3.4. By contrast, T20 is a mature oak within the centre of the ancient woodland. Assessment of its stem shows two primary, longitudinal shear cracks extending to c. 2m above ground level on the north and south sides. A third shear crack of similar size and nature exists of the west side, but this has been surrounded by wound wood development. These defects are consistent with the damage caused by a significant past wind event, such as The Great Storm of 1987, and constitute the partial failure of the trunk.

*Photograph 1: (below left), showing the open longitudinal cracking on the north aspect. Screwdriver shown for scale;*

*Photograph 2: (below centre), showing the partially occluded shear crack on the west aspect; and*

*Photograph 3: (below right), showing the open longitudinal cracking on the south aspect.*

4.3.7. The VALID App has categorised this tree as a **Not Tolerable** risk and as such, it would be prudent to carry out remedial works. To maximise the ecological benefits of the tree with regard to habitat provision, shelter and food source(s), I recommend that the tree is removed to form an 8m tall woodland monolith, also referred to as a 'snag'. This will significantly reduce wind loading, while enabling the safe retention of the valuable trunk wood.

| Tree number | Species | Comments | Risk Rating |
|---|---|---|---|
| T20 | English oak | Fell to form 8m tall woodland trunk. | <b>Not Tolerable</b> |

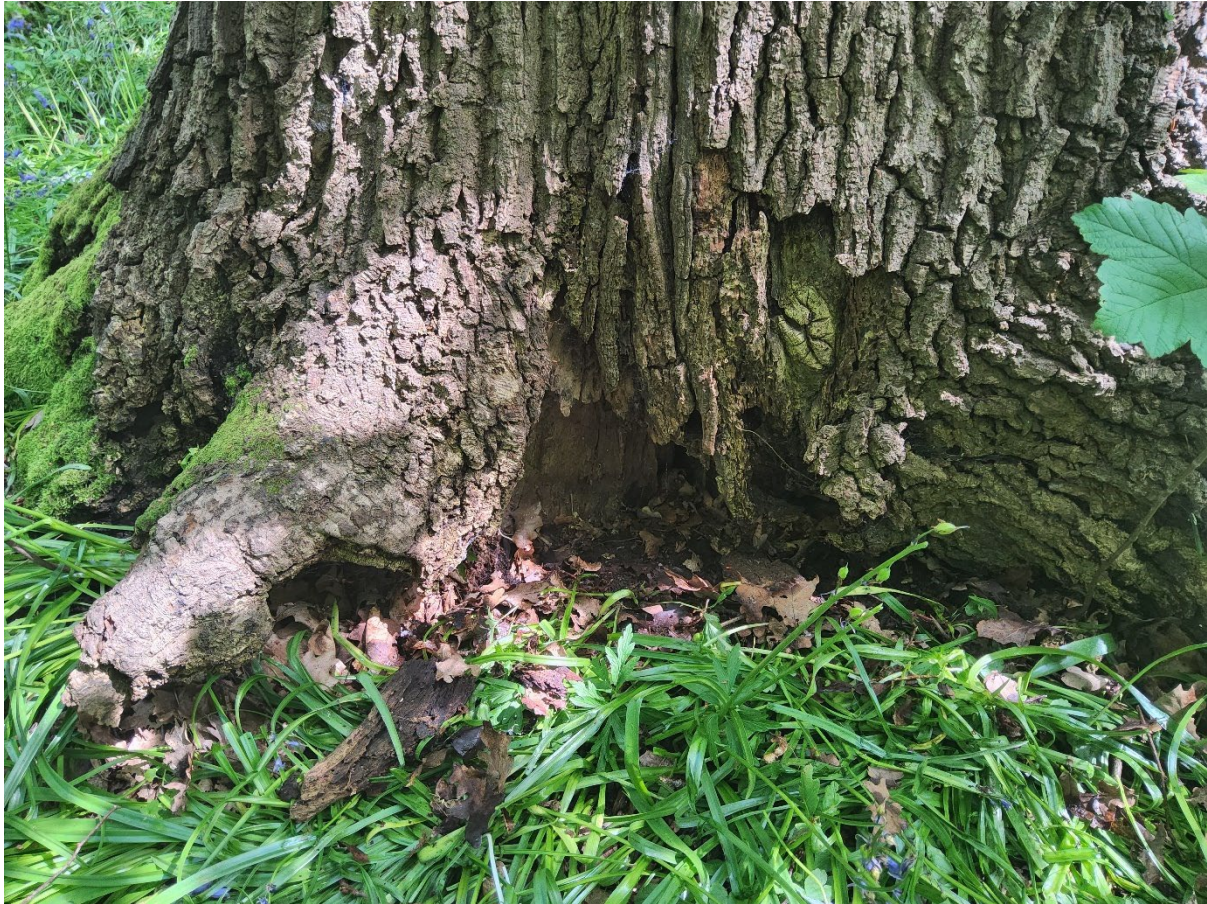
4.3.5. In addition to the cracking, I noted that one of the prominent buttresses roots on the west aspect has been undermined and as such, no longer provides any anchorage to the soil. This is located on the tension side of the trunks slight lean, and would likely have been of considerable importance on the tree's overall stability when intact.

*Photograph 4: showing the undermined buttress root and incipient basal decay on the west aspect.*

4.3.6. Finally, the tree's ability to successfully overcome these structural defects is limited by the sparse nature of its canopy, which is suggestive of generally low vitality. Low vitality means that the tree will be able to generate only a proportion of its potential energy reserves, reducing efficiency and therefore, the amount of resources available for other means, such as woundwood development.

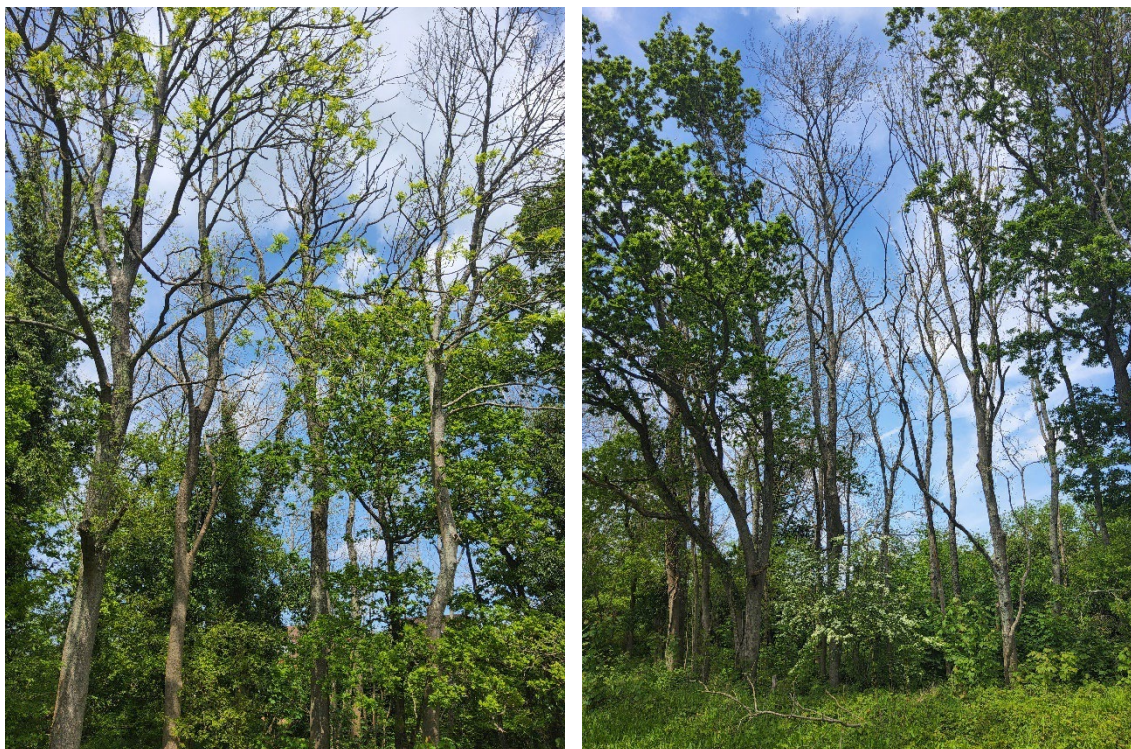
4.3.8. The eastern end of the ancient woodland differs in nature from the west, in that tree size becomes smaller, but at a higher density. Ash is the primary species in this area, and these trees appear to be infected with Ash Dieback Disease (*Hymenoscyphus fraxineus*) to varying extents. The infected specimens are highlighted indicatively on the attached tree survey plan as **red trunks and canopies**.

*Photograph 5: (below left), showing moderate Ash Dieback Disease symptoms towards the eastern end of Knowle Wood; and*

*Photograph 6: (below right), showing severe Ash Dieback Disease symptoms.*

4.3.9. Tree felling is a restricted activity under The Forestry Act 1967. Moreover, current government advice on the felling of Ash Dieback Disease-related trees (UK Government, 2021) states that a felling licence will be required '**unless the trees are dead or pose a real and immediate danger**'. In this instance, the risks are unlikely to be considered immediate and therefore, I recommend contacting The Forestry Commission and submitting an application for a felling licence.

| Tree number | Species | Comments | Risk Rating |
|---|---|---|---|
| G2 | Ash | Remove individuals with moderate and severe foliar symptoms of Ash Dieback Disease. | <b>Not Assessed</b> |
| G3 | Ash | Remove individuals with moderate and severe foliar symptoms of Ash Dieback Disease. | <b>Not Assessed</b> |
